Adapting K1100 Throttle Bodies

A popular modification to the K75's big brother, the K100, is to replace the OEM throttle bodies with K1100 throttle bodies. Changing the throttle body assembly improves the performance of the engine because the throat of the K1100 TBs are larger in diameter by 1mm or so but smooth all the way down the throat and not stepped like the K100; more air can enter the system. When it comes to a K100, this change is a direct swap of parts, although there is some fiddling to do with the throttle cable adapter to ensure that the K100 throttle will properly actuate the K1100 throttle cam.

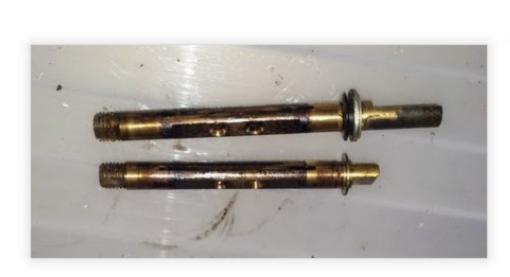
differences. The K100 TPS will attach to the K1100 but the shaft is too short and of the wrong shape to engage the K100 TPS. Luckily the shape and length of the pivots on the shaft are the same, meaning that the shafts are interchangeable. The solution to the TPS problem is to substitute the butterfly shaft on TB4 with the old one from the K75 throttle body. As you will note from the photo, the K100 shaft is longer than the K1100. This is the extra length necessary to get the K100 TPS to work. What may not be readily apparent from the photo is that the placement of the circlip on each shaft is slightly different. This causes a problem with air

Along with the functional differences, there are mechanical

leakage from the TPS which can be easily rectified.

To exchange the shafts:

On the K75 TB

I removed the nut and washer holding the actuating cam, removed the two screws holding the butterfly in place, removed the butterfly from the bottom of the TB and pulled out the shaft. There are two rubber washers that seal each end of the shaft and a spacer washer on one end that will also need to be removed and saved.

On the K1100 TB

I removed the nut and washer holding the actuating cam, removed the two screws holding the butterfly in place, removed the butterfly from the bottom of the TB and pulled out the shaft. There is one rubber washers that seals one end of the shaft and a spacer washer on the other end that will also need to be removed and saved.

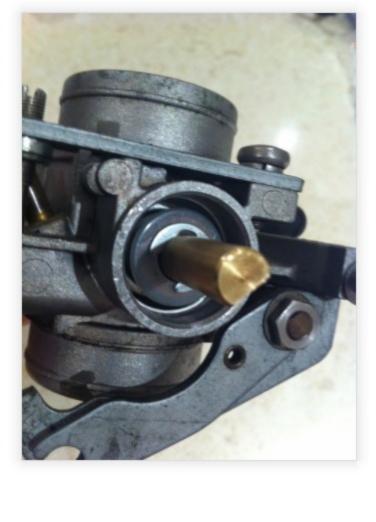
both spacer washers and an additional 1.5mm thick washer will be required. If these are neglected, the shaft will not seal at the TPS end resulting in measurable air leakage around the shaft that causes upset in the engine. On my TB, I found a 1.5mm thick nylon washer that I used for spacing the shaft (see photo to the right). Pile all three washers against the circlip, insert the K75 shaft into the K1100 TB body, seal the cam side with one of the saved washers (flared side facing outwards) and fasten the fast idle cam onto the shaft. When the shafts are exchanged and the cam replaced, check lateral play in the shaft. It should be minimal, about 0.2mm. It will be necessary to ensure that the butterfly completely seats across the throat of the throttle body. There is significant play in the butterfly and setting its position correctly is critical to making the modification work. When the butterfly is seated properly, tighten the two screws that secure it to the shaft. Check the operation of the throttle body to ensure it is not binding and that the butterfly nearly seals the throat of the TB completely. Holding the TB up to the light will show only a sliver of light shining through.

Because of the position difference where the circlip is placed on the K75 shaft,

The throttle cam should move fully through its motion without binding and all three butterfly valves should be nearly closed.

Re-install the K1100 TB onto the rail and recheck the operation of the assembly.

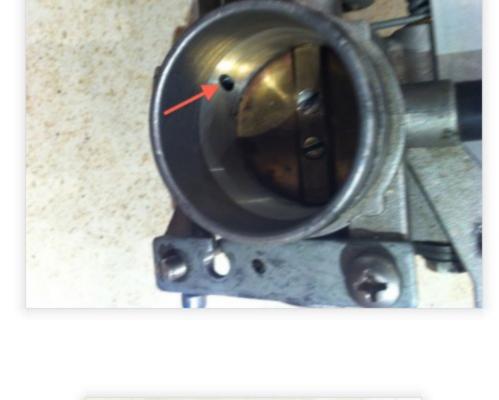
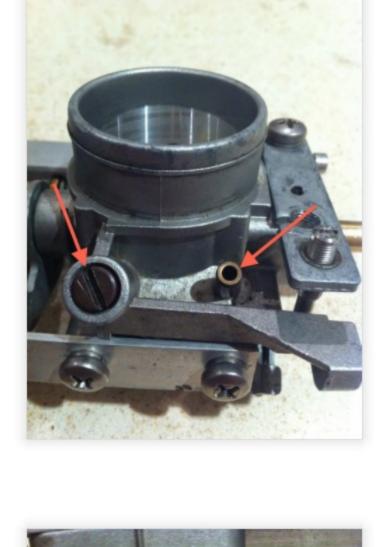
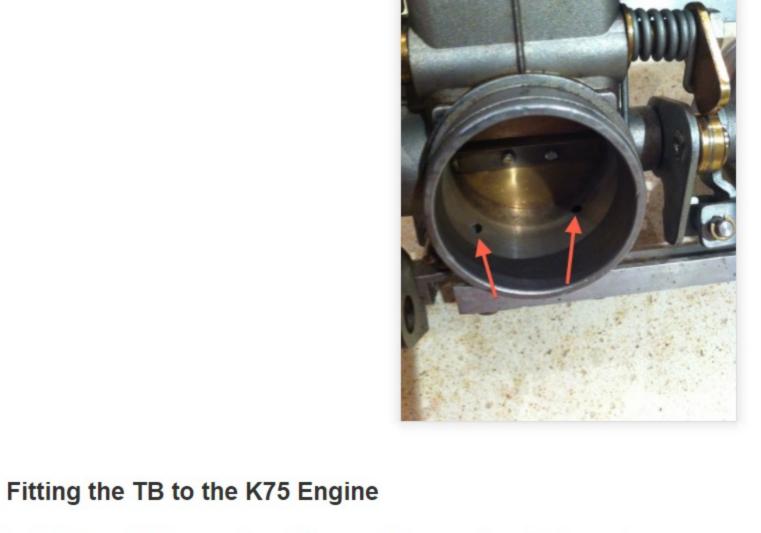
I wanted to be sure that all the orifices in the TBs were clean and clear so I used a pipe cleaner and carb cleaner to

remove all residue from the vacuum ports and air bypass orifices. These photos show those openings that need

attention.
